# LINDSTRAND HOT AIR BALLOONS LTD

## SERVICE BULLETIN NO. 12

ISSUE 2 – DATED 10-05-2012

**TITLE:** Female ACME Thread Hose Connectors (Rego type)

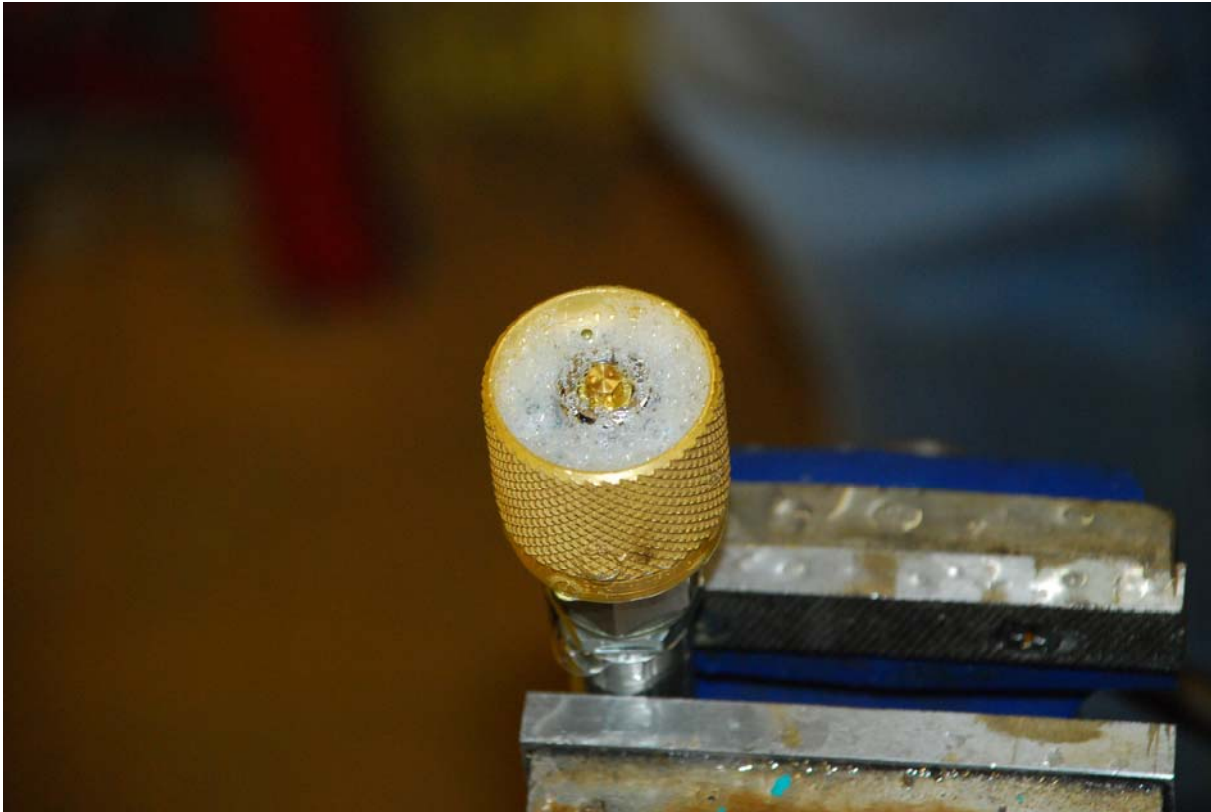
**Background:** We have had three reported incidents of the female ACME threaded connectors (Rego type) leaking when connected to the cylinder with the cylinder valve turned on. Investigation into the cause of these failures has revealed the possibility that other similar connectors produced between the dates given above may not have been assembled with sufficient tightness.

**Photo 1 Coupling showing a leak.**

If a leak is detected then follow this procedure to tighten the threaded connection.
